DEPARTMENT OF PLANNING AND LAND USE

GROUNDWATER MONITORING RESULTS - BOULEVARD/PROPOSED CAMPO LANDFILL AREA

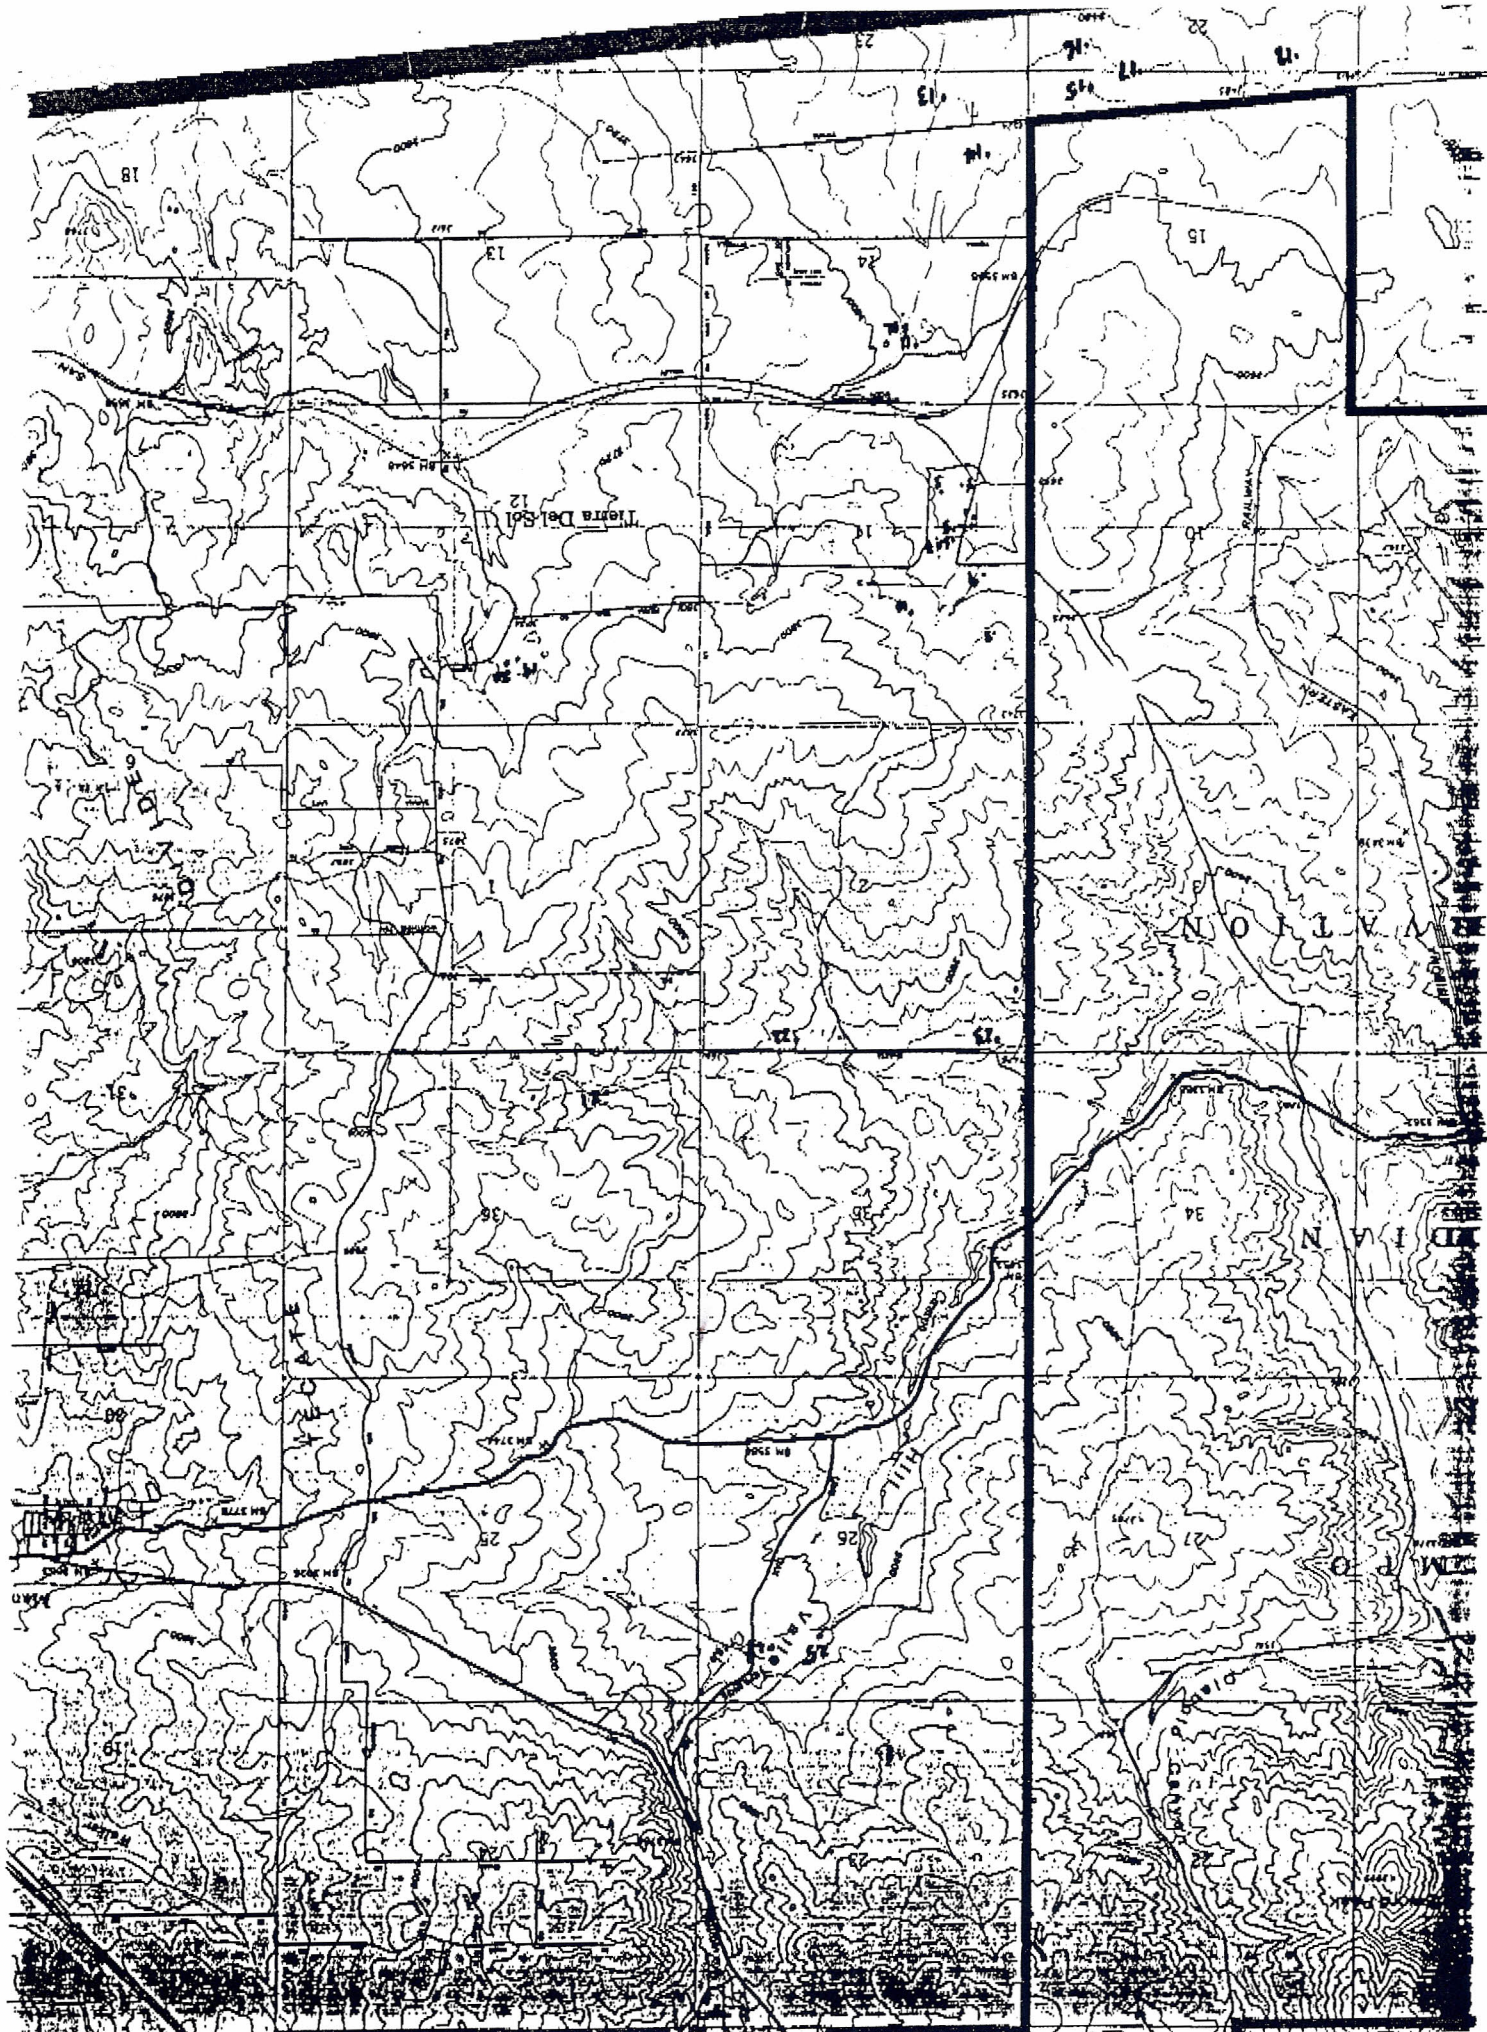
Results of the monitoring are presented in Table 1. A location map of the monitored wells is presented in Figure 1. A total of 25 wells were measured and water levels varied from 1.2 feet above land surface (flowing artesian) to 31.5 feet below land surface (BLS). Groundwater levels in all but 5 of the 25 monitored wells were less than 4 feet BLS. Surfacing groundwater (springs) was noted virtually everywhere throughout the monitoring area including both topographically high and low areas. Rainfall had not occurred for over a week prior to monitoring so that the surface water noted is virtually all surfacing groundwater.
